APPENDIX D
SITE PHOTOGRAPHS

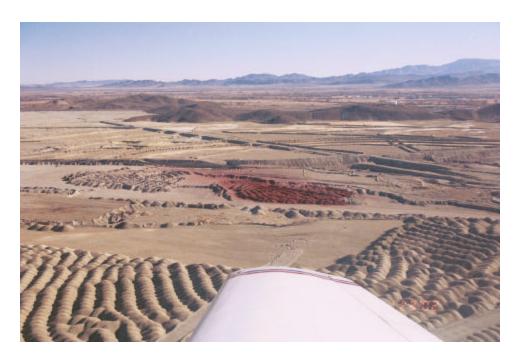
Photo 1 Looking northeast across surface of Oxide Tailings Area ("mounds" in foreground). (1/23/2002)

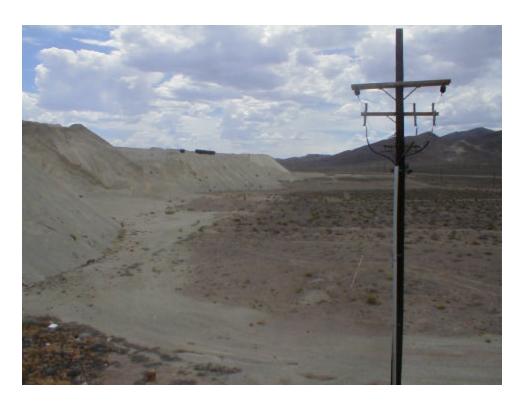
Photo 2 Looking southward along west face of Oxide Tailings Area. (7/12/2002)

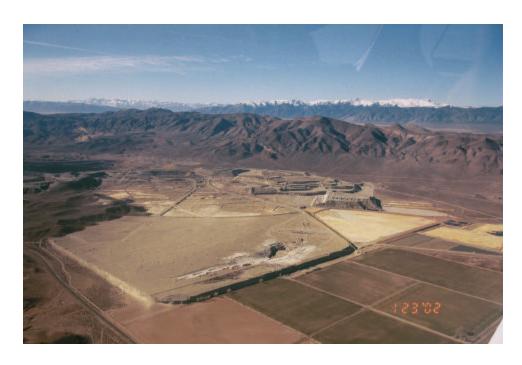
Photo 3
Looking southwest over Sulfide Tailings with agricultural fields in foreground. (1/23/2002)

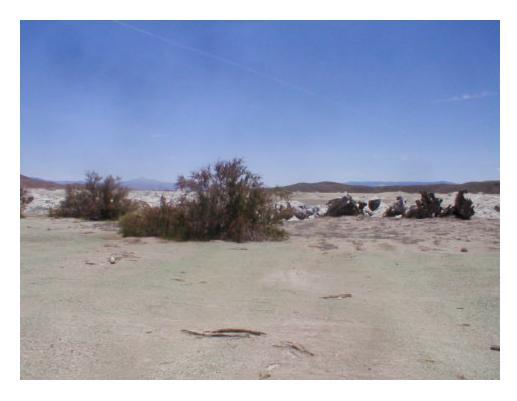
Photo 4
Looking southward over VLT-covered surface of Sulfide Tailings Area – saltcedar and other shrub growth. (5/24/2002)

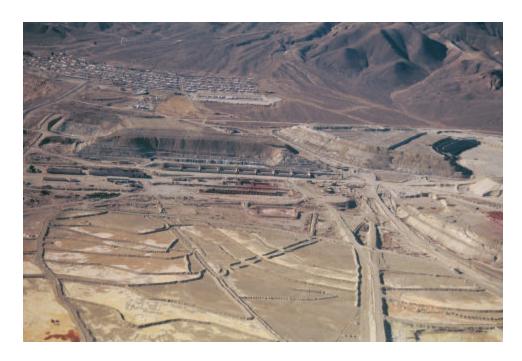
Photo 5 Looking southwest over Process Solution Recycling Ponds. (1/23/2002)

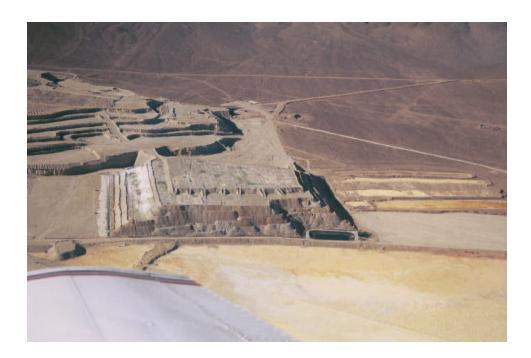
$\begin{array}{c} Photo\ 6\\ Looking\ southwest\ over\ Unlined\ Evaporation\ Ponds\ to\ the\ east\ and\ north\\ of\ the\ Phase\ IV-VLT\ Heap\ Leach.\ (1/23/2002) \end{array}$

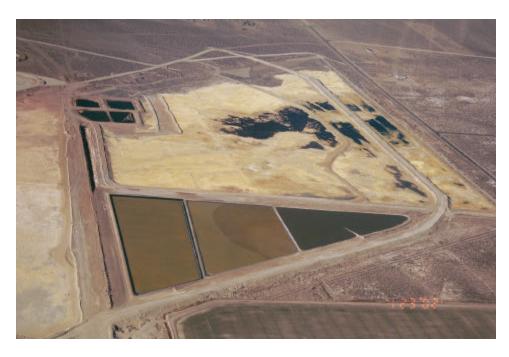
Photo 7
Looking west over lined Pumpback Evaporation Ponds, Lined
Evaporation Ponds and the Weed Heights Sewage Lagoons. (1/23/2002)

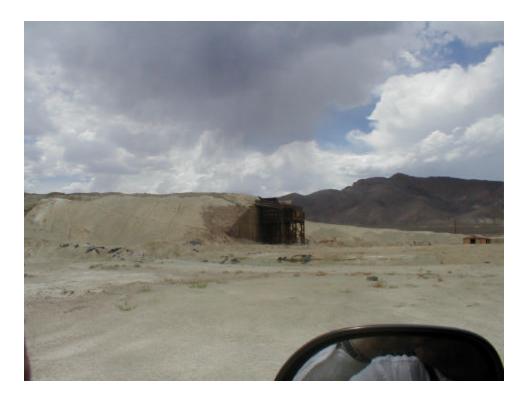
Photo 8
Looking west at north face of Oxide Tailings and abandoned crusher or bin support structure. (7/12/2002)
